This paper reviews the main factors that caused piping in five earth dams built in Cuba in the late 1980's. As a common geological feature we can mention that the dams were built in alluvial basins consisting of bedded granular particles. These soils are characterised by a high permeability. In the situation where the continuity of the layers under the dam foundation is extended downstream, the likelihood of occurrence of piping is very high.

PIPING PHENOMENON IN EARTH DAMS: CASE HISTORIES

R. VÁZQUEZ BALLONA¹ - M. ALVAREZ GRIMA²

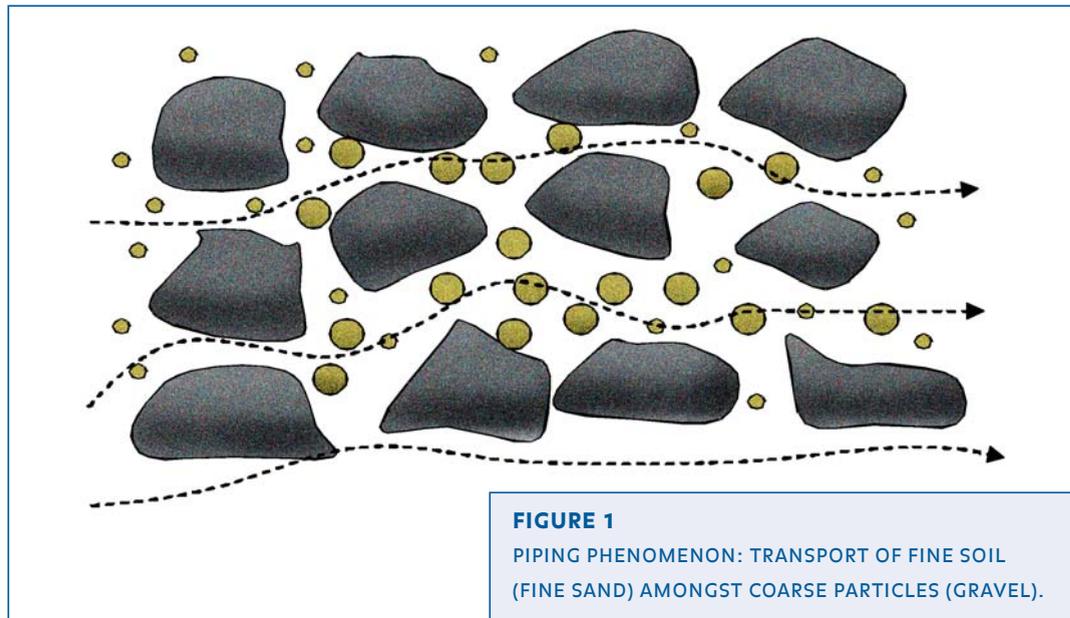
Piping occurs when water seeps through the soil and tends to transport the soil particles with it. This generally occurs when the pore sizes are larger than the soil particles (*Figure 1*). This phenomenon occurs in sites composed of soils characterised by a high permeability. As a consequence, a change of water flow rate occurs and the piping process commences, giving rise to an outcrop of water seepage. As a result of this, the finest soil particles are washed away with the water flow. The diameter and the depth of the resulting hole will enlarge in time, bringing into existence the piping through which the reservoir and lower dam slope toe are connected (*Figure 2*). Piping can occur along a spillway and other conduits through the embankment. Sinkholes that develop on the embankment are signs that piping has commenced. A whirlpool in the reservoir surface may soon follow and then likely a rapid and complete failure of the dam. Emergency procedures, including downstream evacuation, must be rapidly implemented if this condition is observed.

FIGURE 1
PIPING PHENOMENON: TRANSPORT OF FINE SOIL (FINE SAND) AMONGST COARSE PARTICLES (GRAVEL).

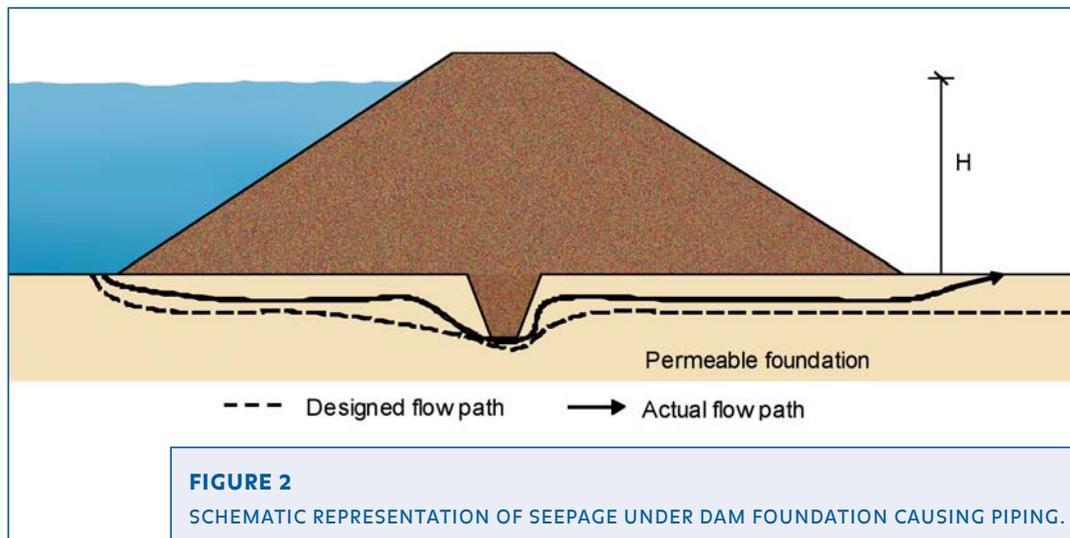
FIGURE 2
SCHEMATIC REPRESENTATION OF SEEPAGE UNDER DAM FOUNDATION CAUSING PIPING.

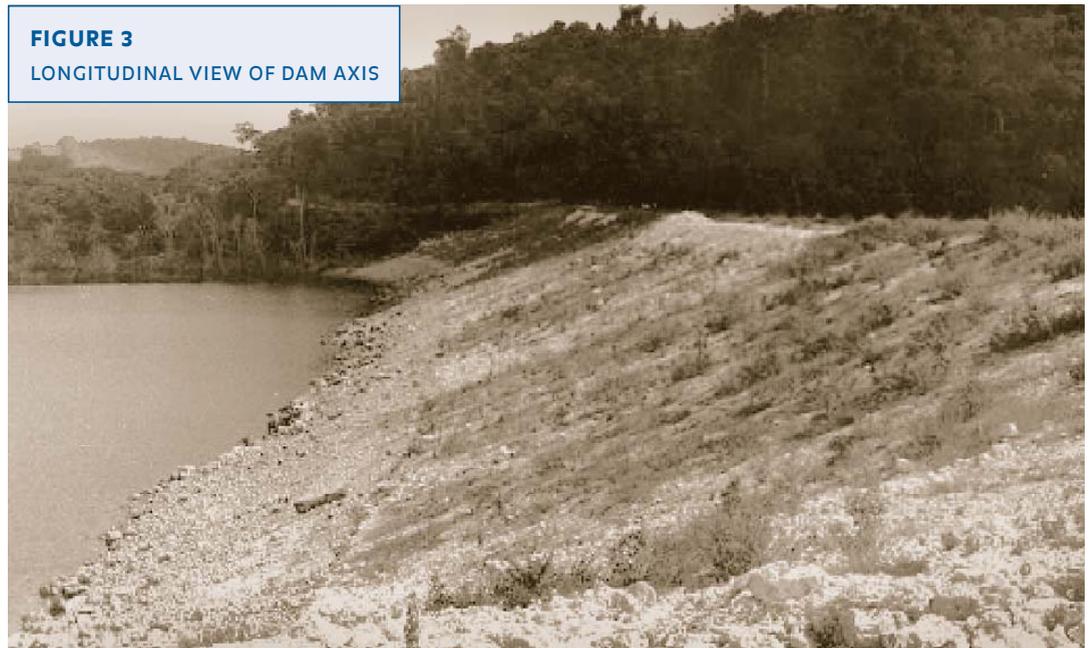
The failure can be shown as a sudden raising of the foundation at the apron of the embankment. This undermining is generally caused by a gradual increase of piping, and it can lead to the appearance of ruptures such as longitudinal and transversal cracks on the embankment (*Figures 3 and 4*). The most dangerous ruptures are transversal cracks, in as much as if they appear on the same level with the banked-up water level, a new outlet of reservoir

FIGURE 3 LONGITUDINAL VIEW OF DAM AXIS

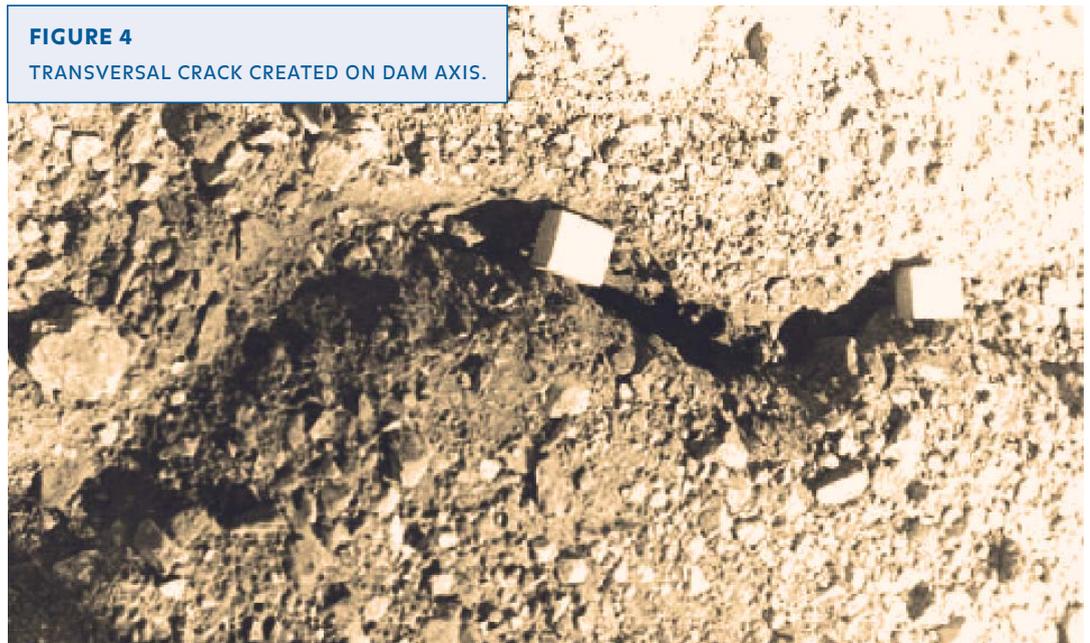
FIGURE 4 TRANSVERSAL CRACK CREATED ON DAM AXIS.

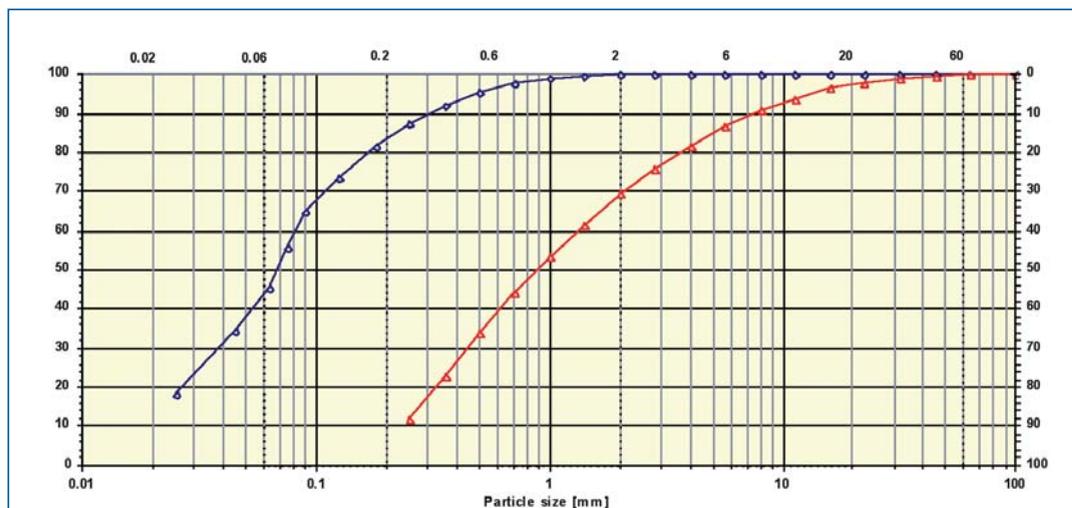
Properties of the piped soils in the five dams were analysed. In all cases the soil consisted mainly of non-cohesive granular particles: fine and medium sand (Figure 5). They had a vertical permeability of $K=0.5-10$ m/day. The horizontal permeability varied between 5-50 m/day. In fact, this is characteristic for Cuban alluvial terraces where the dams were built.

The analysis of the results revealed that the piped soils had more than 50% of granular particles and the transported particles consisted mainly of fine and medium sand (Figure 5). Moreover, we could

FIGURE 5
GRAIN SIZE DISTRIBUTION RANGE OF PIPED SOILS.

verify that for the piped soils with a low value of hydraulic load ($\Delta H=3-6$ m) and a low hydraulic gradient ($i=0.06-0.13$) piping can occur; provided that granular layers are laying underneath the dam foundation. The presence of fine particles (0.2-2.0 mm) in large amounts can also be an indicator for the possible occurrence of piping based on the grain size distribution of the piped soils.
