Paul Hölscher
Deltares

DEVELOPMENT OF ADVANCED PILE INTEGRITY TEST METHODS FOR CAST IN-SITU PILES

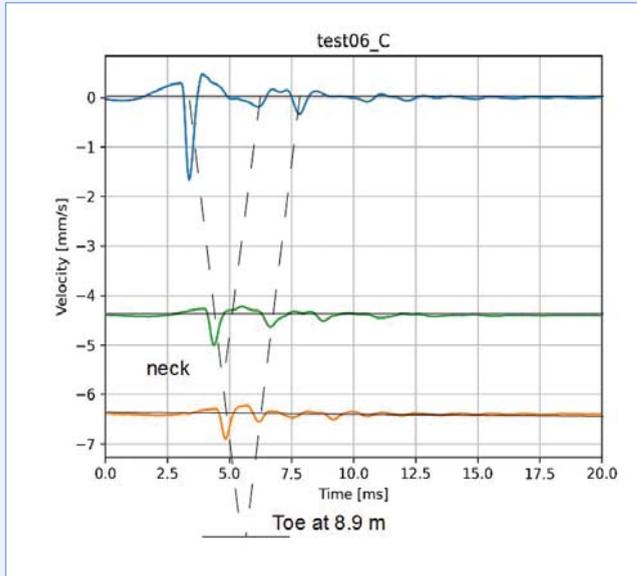
Figure 2 – Results of Deep Acoustic Check at pile 6.

Figure 2 shows an example of a measurement on Pile 6. The figure is presented as a seismogram, with on the horizontal axis the time, and on the vertical axis the position and amplitude. Pile 6 has one transducer at the pile head and two deep transducers at 4.4 m and 6.4 m under the pile head. Figure 3 shows similar results for pile 8. The signal

Figure 2 shows that the actual wave speed can be determined accurately. The determined propagation of the waves is shown by dashed lines. For this short pile this is not very relevant, but for longer piles the uncertainty on wave speed hinders the accurate determination of pile length. The deep transducers solve this quandary.

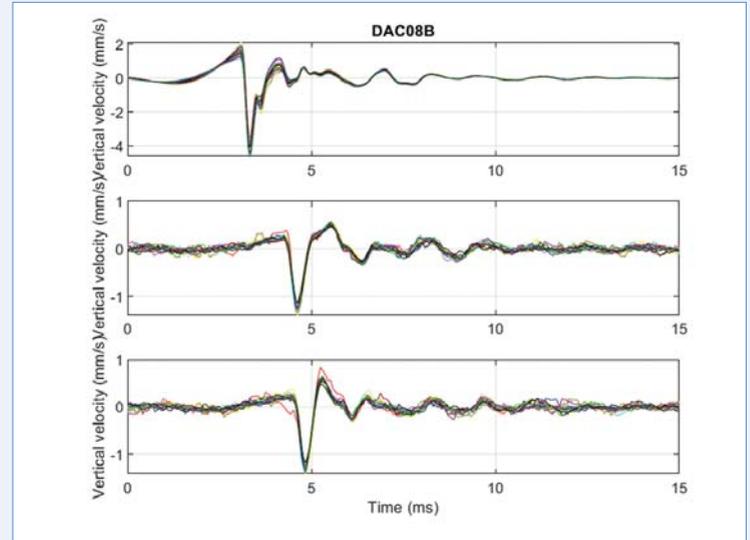
Figure 3 – Results of Deep Acoustic Check at pile 8.

of the transducer at the head suffers from the integration. This suggest that for this position the mems require a very high sampling rate to be able to integrate to velocity. A traditional transducer might be preferable. Deeper transducers have less influence of this aspect, presumably since the very high frequencies are damped during propagation.

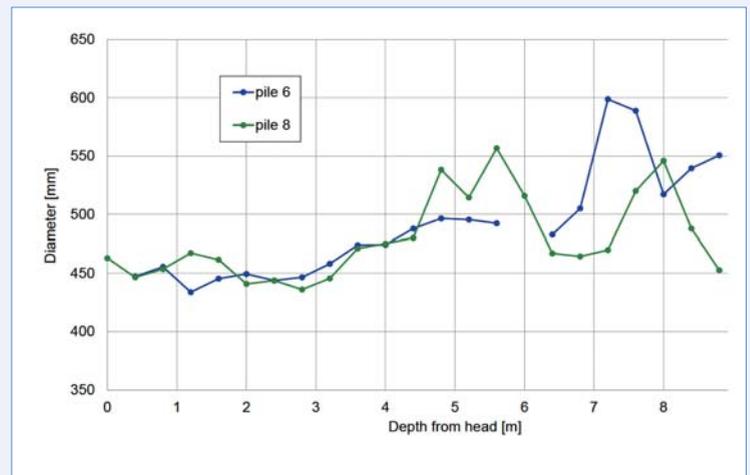
Figure 4 – Diameter of piles from measured circumference for pile 6 and pile 8.

Figure 4 shows the diameter on depth for both pile 6 and 8. The circumference had been measured,

and under the assumption of a circular cross-section, the diameter is derived. Pile 6 has a clear bulge close to the toe. The transducers are well above the defect, but this defect is close to the toe. The toe reflection hinders the interpretation. Pile 8 has two bulges. The two transducers are in the highest (closest to the pile head) bulge. This complicates the interpretation.

The interpretation shows that the transducer should be located a sufficient distance above the defects. This distance should be at least the length of the impact wave in the pile. In this case, the wave speed is 4500 m/s and duration of the blow

is 0.7 ms. The length of the wave is thus 3.1 m. The transducer is 1.6 m above the neck, so the incoming wave and reflected wave are interfering. However, the different shape of the measured signal at top and at depth shows that there is a neck below.

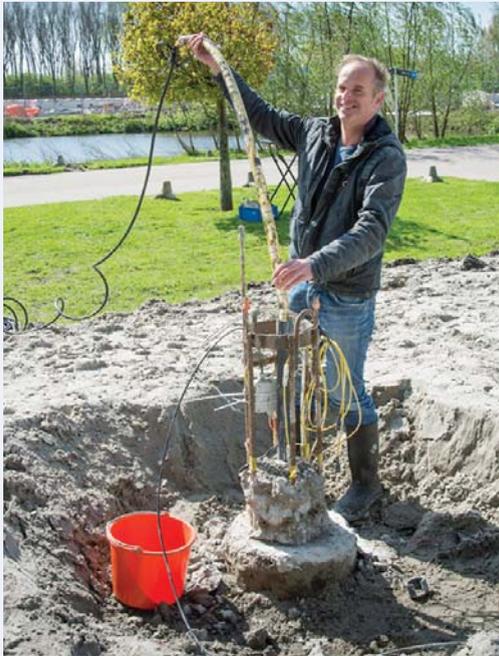
Figure 5 – The seismic tube is placed in the hole in a pile.

The instrument is lowered into a tubular hole in the pile, see Figure 5. By performing the measurement with the Seismic Tube at different heights, a measurement is obtained that is comparable to the Single Hole Sonic Logger. However, the presence of eight transducers (instead of one, as with the SHSL) makes it possible to apply seismic interpretation techniques.

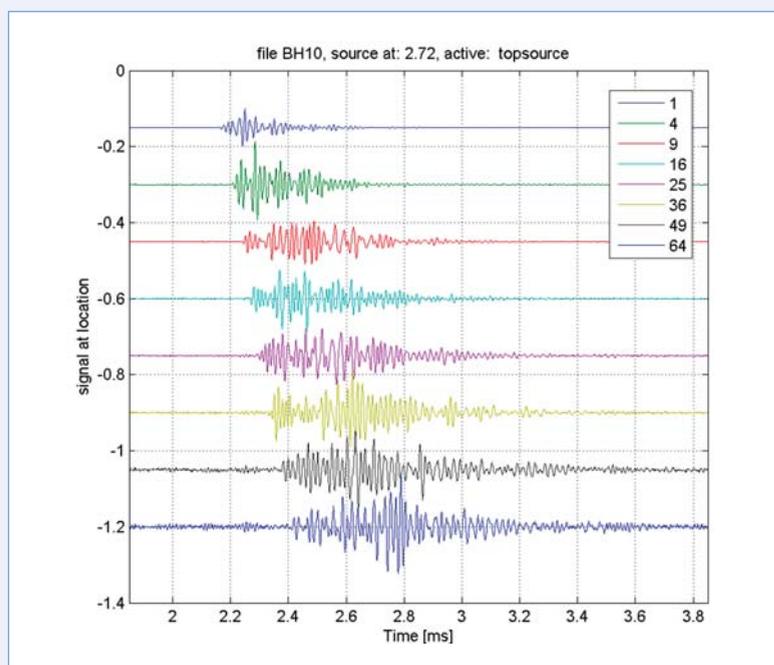
Figure 6 – Measurement in Pile 13 at 5.67 m depth presented as seismogram. The legend presents the multiplication factors for the signals.

Figure 6 shows a measurement as seismogram, i.e. the time signals are presented at the position where it is measured. The signals are multiplied with a factor that is proportional with the distance between the transducer and the source. This

avoids that the decay of the signals makes the signals further away almost invisible.

This figure suggests that the decay is quadratic with distance. However, the cumulative energy in the signals shows that the energy decay is less, about amplitude multiplied with square root of amplitude.

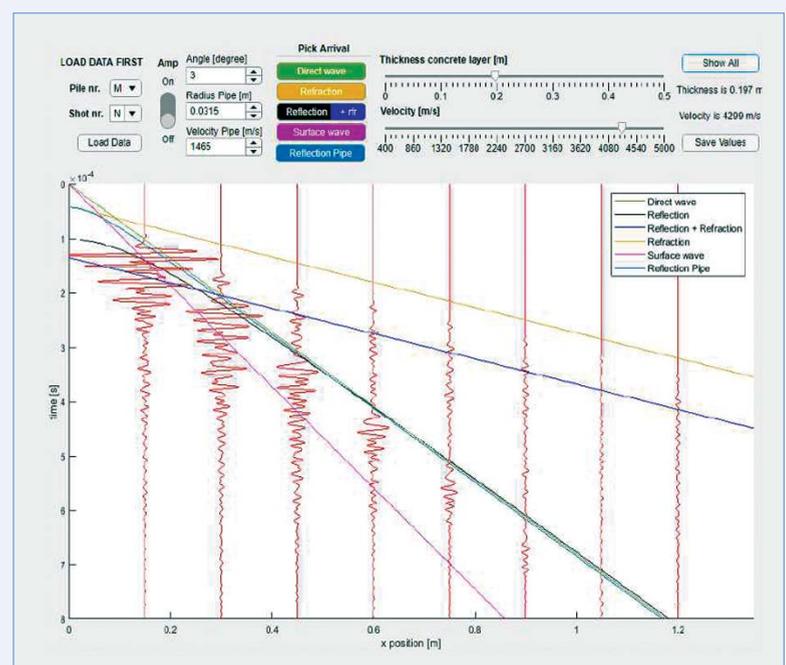
Figure 3 – Example of wave picking tool, showing the complex wave system [7].

Veltmeijer also created an interpretation tool that can be used for picking the waves from the measured signals Figure 7 shows an example.

The tool shows that the complex structure of the waves propagating in the pile can be understood. The first arrivals give information on the wave speed in the concrete and thus the quality of the concrete in the core. To determine the diameter of the piles locally the reflected waves must be determined, while these waves interfere with the direct waves that arrive in positions further away only slightly earlier.

- a direct wave propagating parallel with the pile axis (straight characteristic)
- a “surface” wave (Stoneley wave) propagating parallel with the pile axis (straight characteristic)
- a refraction wave (curved characteristic)
- a reflected wave (curved characteristic)
- a reflected refraction wave (curved characteristic)
